FEMA P-58/BD-3.9.6

Seismic Fragility of Standard Building Stairs

SEISMIC FRAGILITY OF STANDARD BUILDING STAIRS

prepared for ATC 58 by
Christopher Higgins, Ph.D.

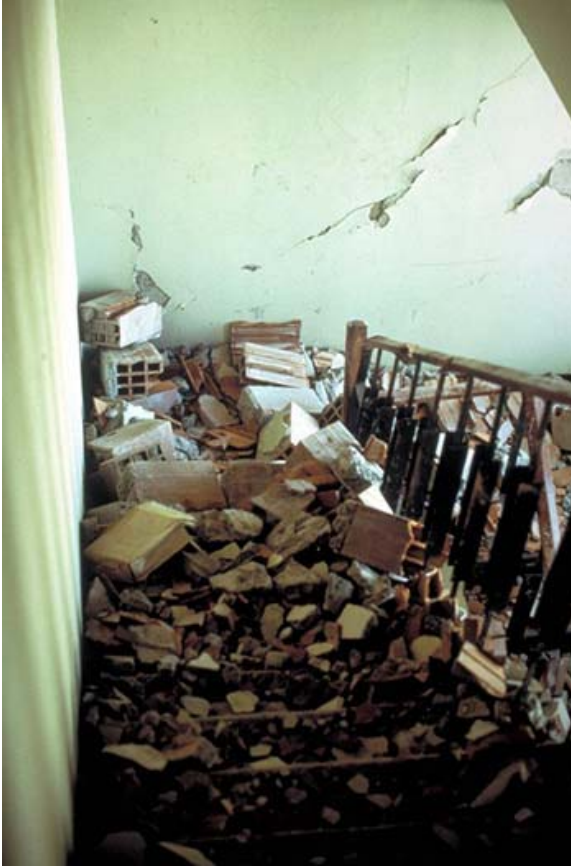
Fig. 3 - Stairway in the Banco Central Building, Managua, Nicaragua (1972 Managua Earthquake). Debris on stairs from the failure of the hollow tile partitions surrounding the stairs (Photo from PEER Godden Collection, No. J94).

Because stairs are often placed within stair shafts, the shafts must be able to accommodate earthquake induced stair deformations without becoming intermediate points of contact. Interaction of the stairs with the shaft walls can induce unintended loads into the stair system and walls. Damage to the shaft walls, produced either autogenously or by stair-shaft wall interaction during an earthquake may result in debris that can block or hinder stairway access as seen in Fig. 3.

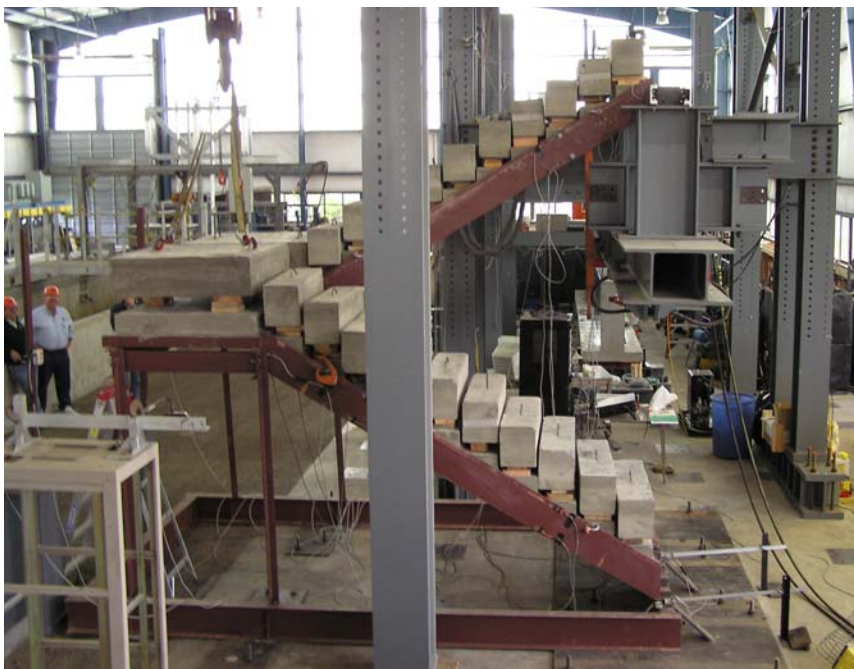
Fig. 6a – Prefabricated steel stair tests (Higgins 2009).

Higgins (2009) conducted tests to assess the seismic performance of prefabricated steel stair assemblies. Two different production-run stair units were tested: checker plate (also called diamond plate) and concrete filled pan stair treads. The stair assemblies included two flights attached to a 1.2 m (4 ft) wide intermediate landing. The stair flights reverse at the landing and each flight has 11 treads 279 mm (11 in.) wide with 166 mm (6.55 in.) high risers (slope = 33 degrees, pitch = rise/run = 0.65). The overall stair specimen is shown in Fig. 6a. The test samples were subjected to simultaneously applied factored

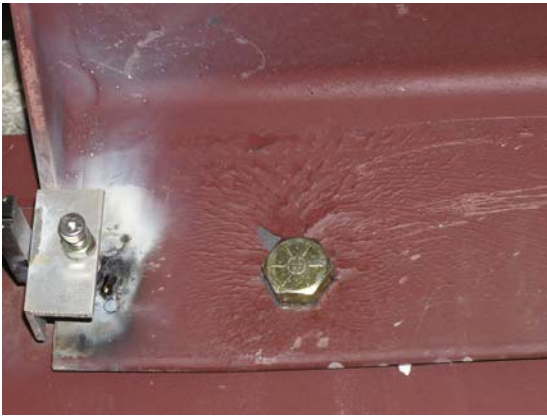
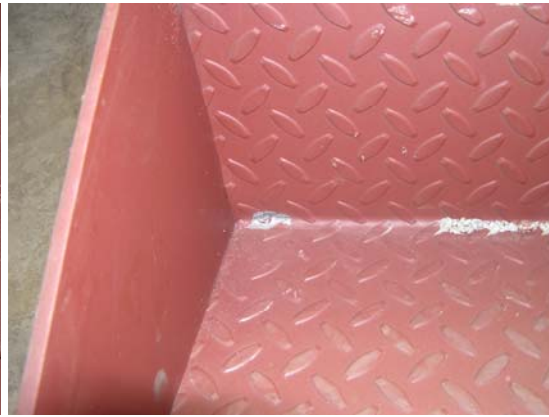
Fig. 7 – Examples of damage state DS1 for stairs a) Yielding around bolted connection (photo by C. Higgins), b) Yielding and paint flaking at stair tread-riser bend (photo by C. Higgins), c) Minor concrete cracking (Simmons 2000).

The first damage state, DS1, consists of nonstructural or minor damage that can be repaired by patching, epoxy injection, painting, or applying a topping or fill material. This type of damage includes local concrete cracking, localized steel yielding, and localized spalling. Examples of these types of damages are shown in Fig. 7 for different stair systems.

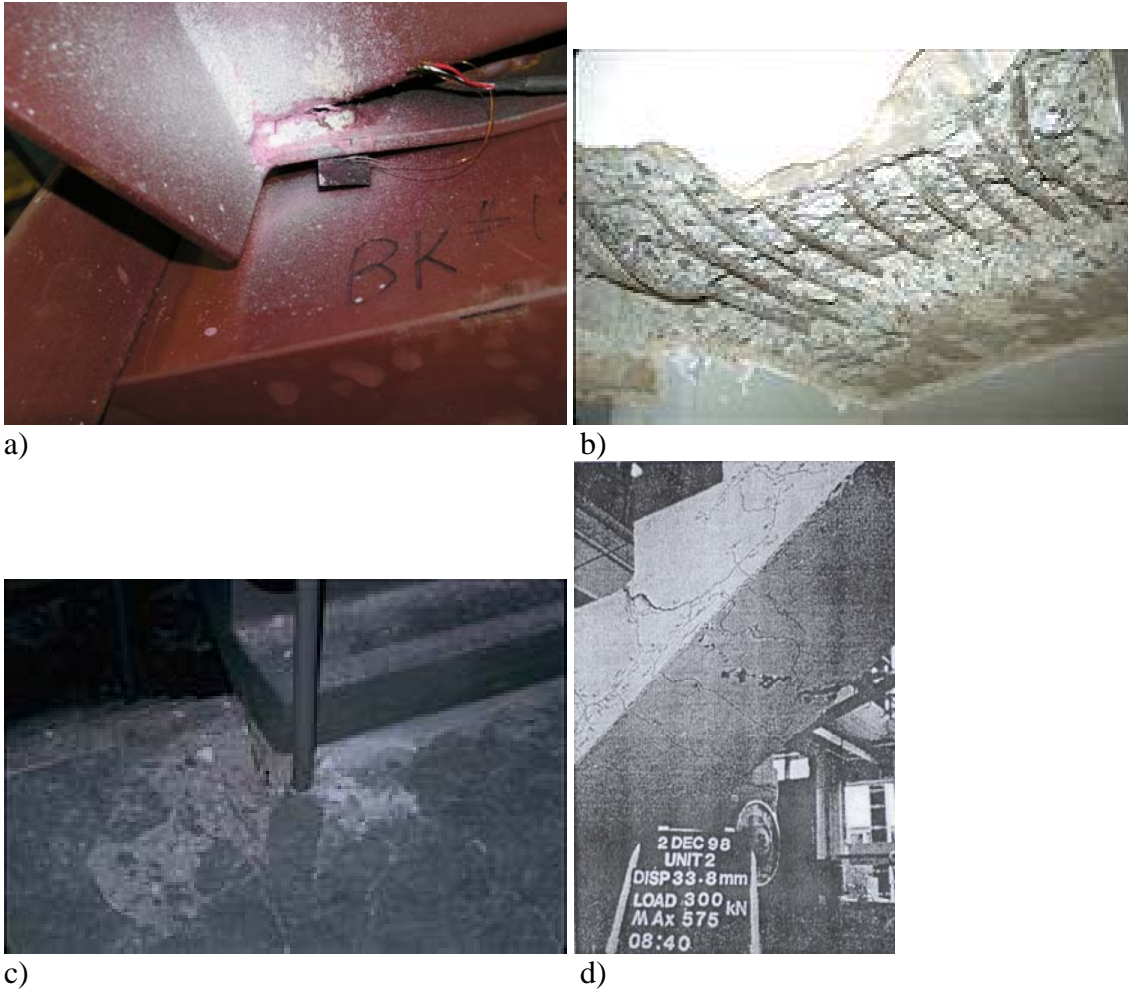
Fig. 8 – Examples of damage state DS2 for stairs: a) Weld cracking on steel stair (photo by C. Higgins), b) spalling of concrete stair (La Union, stair damage, Los Palos Grande District, Caracas, Venezuela, (The Earthquake Engineering Online Archive, Karl V. Steinbrugge Collection: S2170S3558), c) concrete crushing and spalling on upper story stair landing after Anchorage, Alaska earthquake, (The Earthquake Engineering Online Archive, Karl V. Steinbrugge Collection: S2170), d) Concrete crushing, spalling, and significant cracking (Simmons 2000) .

The second damage state, DS2, consists of structural damage such as extensive concrete cracking, concrete crushing, buckling of steel, and weld cracking. Repair of this damage would likely require removal of damaged elements, sections, or materials or extensive field repair. While the repair work required may be extensive, the stairs maintain the ability to carry full design live load. Examples of this type of damage are shown in Fig. 8.

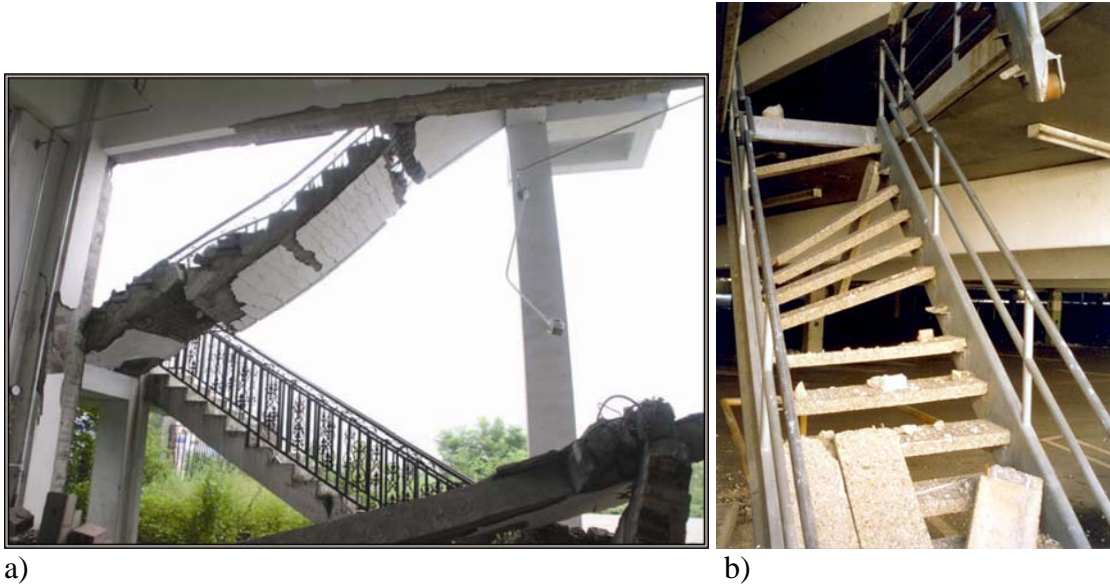
Fig. 9 – Examples of damage state DS3 for stairs; a) Staircase between first and second floors of a two-story RC frame structure building in Dujiangyan, China after 2008 Wenchuan Earthquake. (Photo by Feng Yuan, *Earthquake Engineering and Engineering Vibration* (2009)), b) Hybrid stairway damaged in 1994 Northridge, California earthquake (FEMA 74, 1994 (image inverted at source location)).

The third damage state, DS3, consists of severe damage to the stair system such that it could not support factored live loads and permit egress from the building. The stair system would have to be completely replaced and would have failed the functional design objectives. Examples of this type of damage are shown in Fig. 9.
