FEMA P-58/BD-3.9.15

Fragility of Chillers

Fragility of chillers

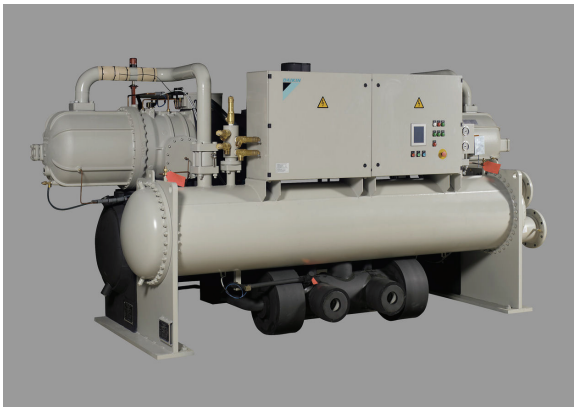
Figure 1. Chiller

| Fragility, damage measures, and consequences for | | |
|--|--|---|
| Basic composition: | Chiller. See Figure 1. | |

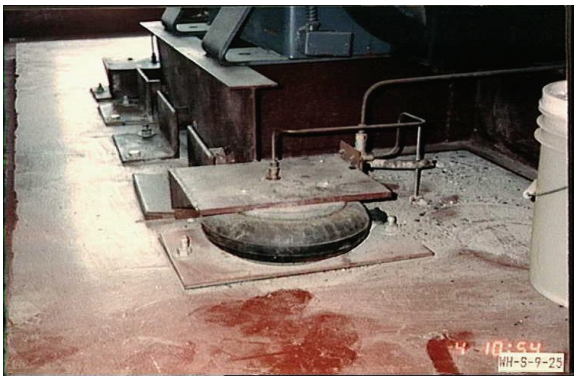
Figure 2. Chiller shifted from rubber pad isolation mount (EPRI)

| Fragility, damage measures, and consequences for | | |
|--|--|---|
| Illustration: | Figure 2 | |
