FEMA P-58/BD-3.9.28

Fragility of Cooling Towers

Fragility of cooling towers

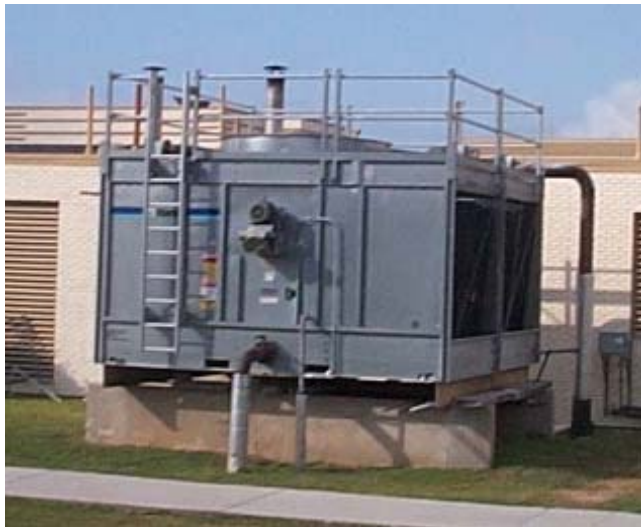
Figure 30. Example cooling tower
